“Samco Raven”

IMO 9107655

Crude Oil Tank Inspection Report

25-26 August 2011

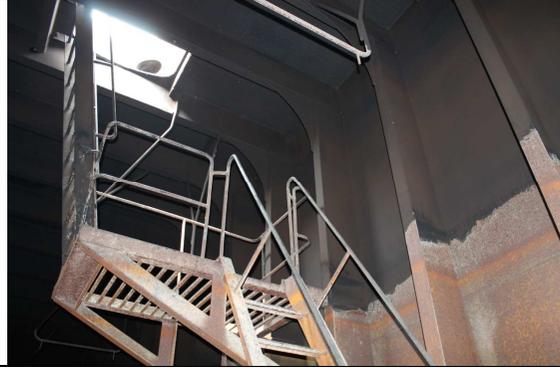
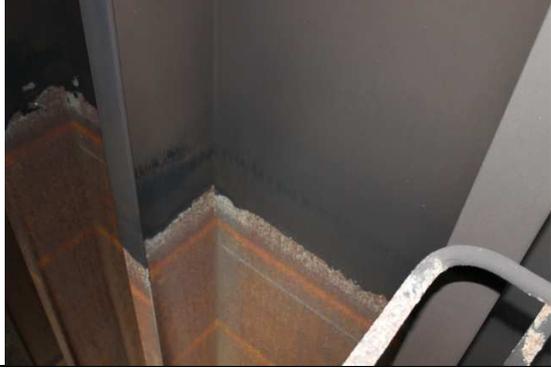
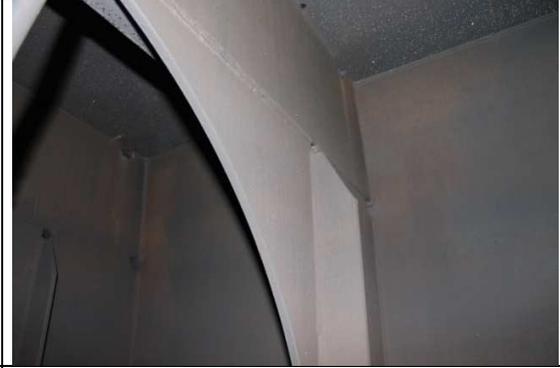
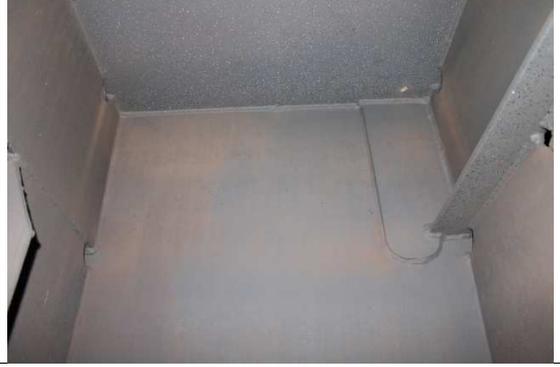
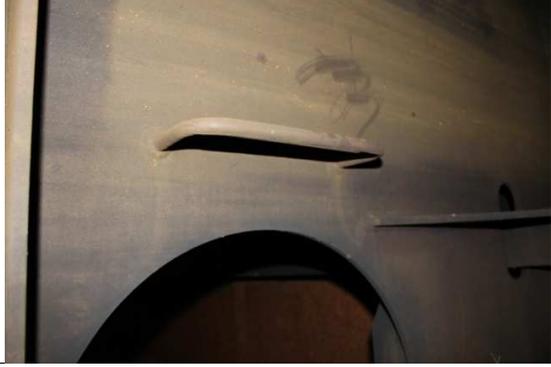
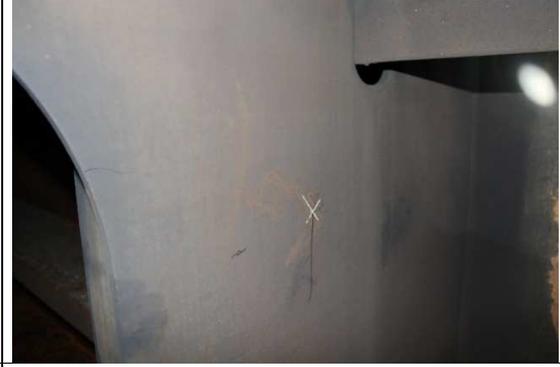
No.5 (S) - Upper		
Photo #1	Photo #2	Photo #3

- Excellent general condition in all areas around tank access, on upper stringer deck and web frames
- No breakdown on edges, weld seams and cut-outs
- One area (approx. 1 sq.cm) of coating on deckhead damaged from hot work carried out on main deck
- No blistering
- Adhesion to steel assessed on web frame (Bay 6) using penknife cross-cut method = Excellent (rating 5/5)
- Total area breakdown <<0.1%

Excellent general condition	Areas around tank access	No breakdown on edges and weld seams
Photo #4	Photo #5	Photo #6

One area (approx. 1 sq.cm) of coating on deckhead damaged by hot work on main deck	No breakdown on edges or hand support	Adhesion to steel check using penknife cross-cut method (rating = 5/5)

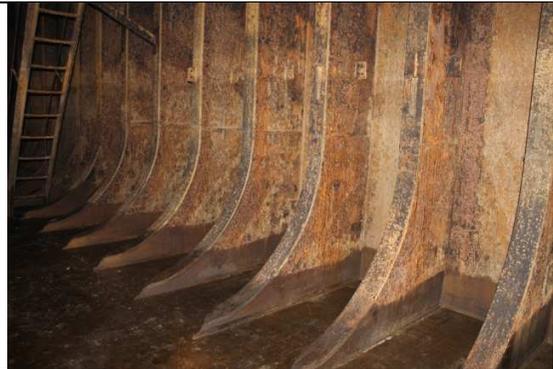
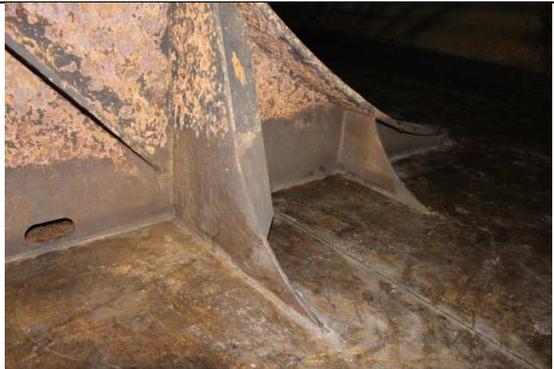
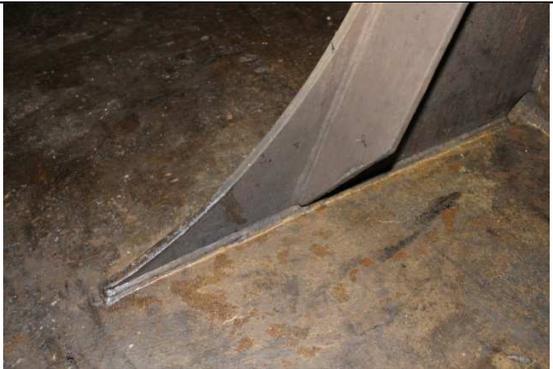
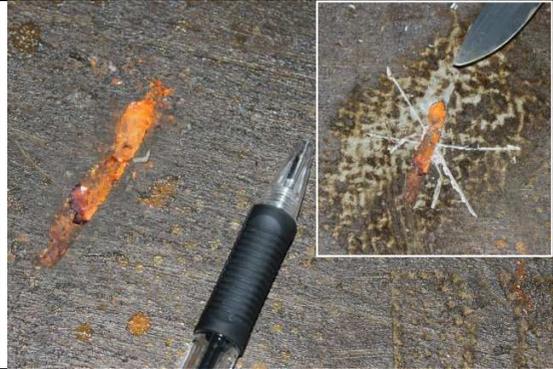
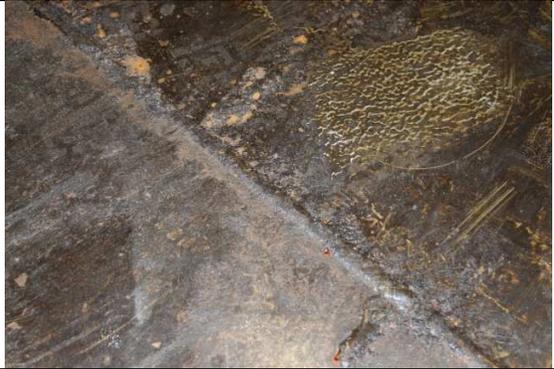
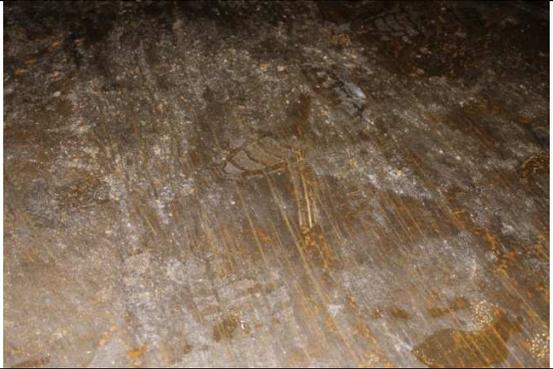
No.5 (S) - Lower		
Photo #7	Photo #8	Photo #9

- Edges and weld seams in excellent general condition with only a few small corrosion spots
- Small pits scattered around the tanktop where corrosion had occurred at points of mechanical damage to coating or where welds had been ground at the new construction stage. Underfilm creep measured as zero (i.e. no loss of adhesion of the coating to the steel in the areas immediately surrounding corrosion pits).
- Coating still fully intact where scratch marks visible from removal of crude oil using shovels
- No blistering

Tanktop	Excellent general condition	No breakdown on edges and weld seams
Photo #10	Photo #11	Photo #12

Corrosion pit as a result of mechanical damage No underfilm creep of coating	Scattered pits on some ground welds	Surface scratches from shovels used to remove crude oil – coating still intact

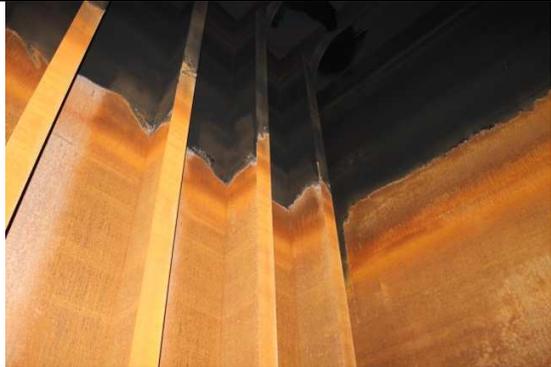
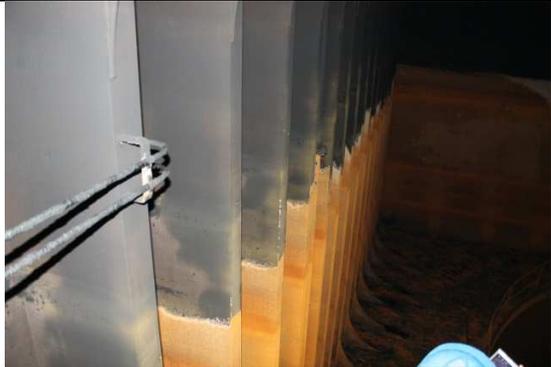
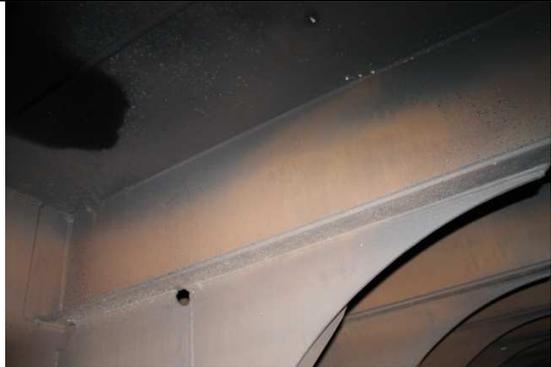
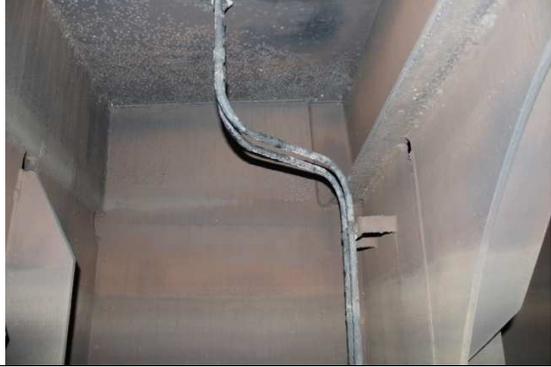
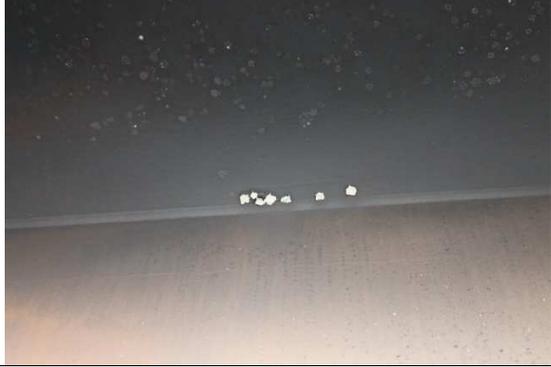
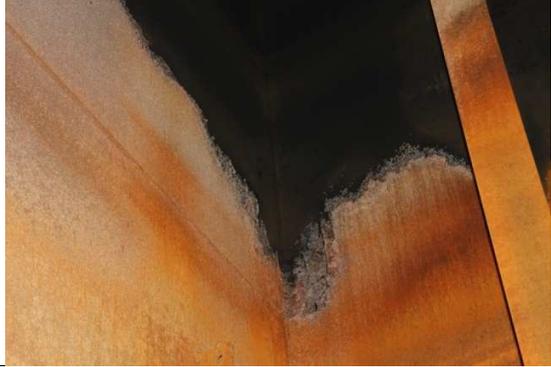
No.5 (C) - Upper		
Photo #13	Photo #14	Photo #15

- Excellent general condition in all areas around tank access, on upper stringer deck and web frames
- Some (very minor) breakdown on edges and weld seams on underside of main deck directly adjacent to tank entrance
- No blistering
- Total area breakdown <0.1%

Coating of deckheads and 2m down bulkheads	Excellent general condition	Deckhead and connecting brackets
Photo #16	Photo #17	Photo #18

Small number of blisters along one weld seam	Small areas of reverse burn damage on underside of main deck	Corrosion of uncoated steel below 2m level

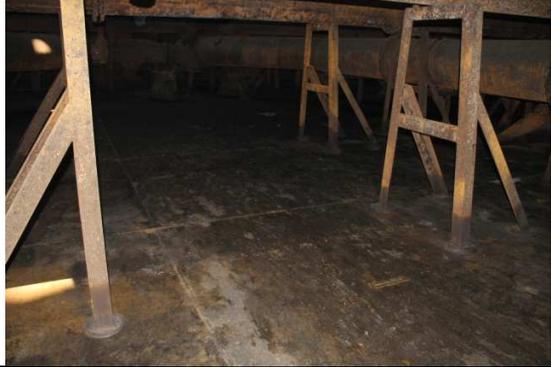
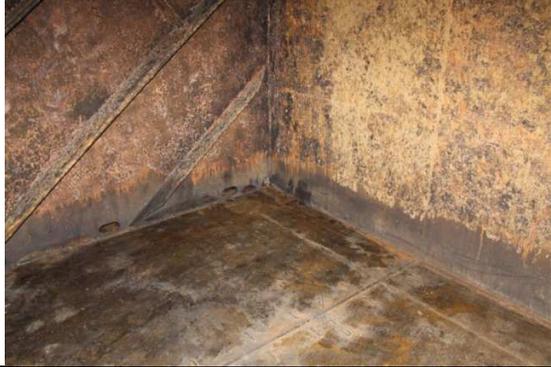
No.5 (C) - Lower		
Photo #19	Photo #20	Photo #21

- Edges, cut-outs and scallops in excellent condition with no breakdown observed
- Some small pits scattered around the tanktop (mainly in Bays 1 and 2) where corrosion had occurred at points of mechanical damage and on welds that had been inadequately ground at the new construction stage. Underfilm creep measured as zero (i.e. no loss of adhesion of the coating to the steel in the areas immediately surrounding corrosion pits).
- Coating still fully intact where scratch marks visible from removal of crude oil using shovels
- No blistering
- Adhesion to steel (Bay 2S) = Excellent (rating 5/5)
- Total area breakdown <0.3%

Tanktop	Excellent general condition	No breakdown on edges of drainage holes
Photo #22	Photo #23	Photo #24

Erection joint (one corrosion pit) and weld seams	Adhesion to steel check (rating = 5/5)	Surface scratches from shovels

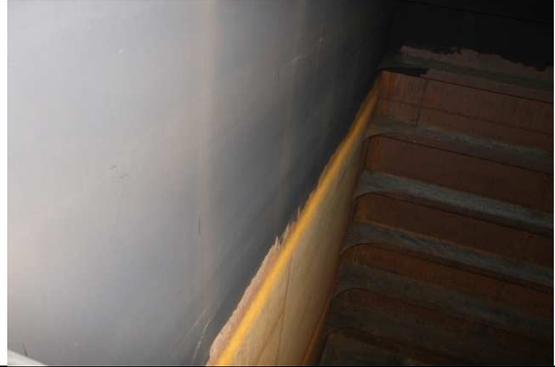
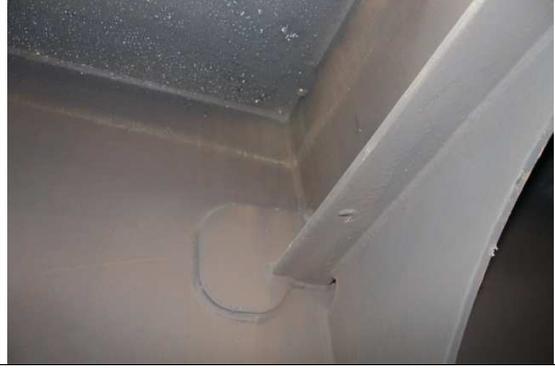
No.4 (S) - Upper	
Photo #25	Photo #26

- Excellent general condition in all areas around tank access
- Minor areas of breakdown on inside of one scallop, one rat-hole and on one edge immediately adjacent to tank entrance
 - No further breakdown observed on any edges, weld seams and cut-outs
- No blistering
- Total area breakdown <0.1%

Excellent general condition	Deckhead and connecting brackets
Photo #27	Photo #28

One small area of breakdown on edge of bracket	Minor breakdown on inside of scallop and edge

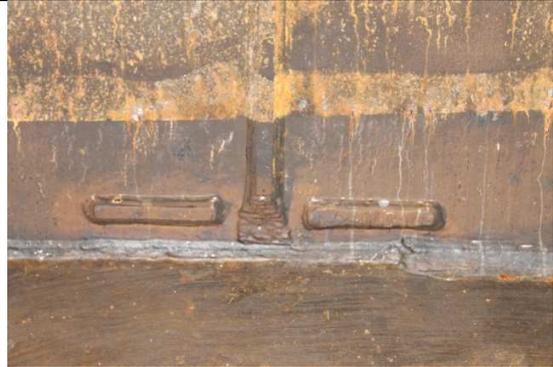
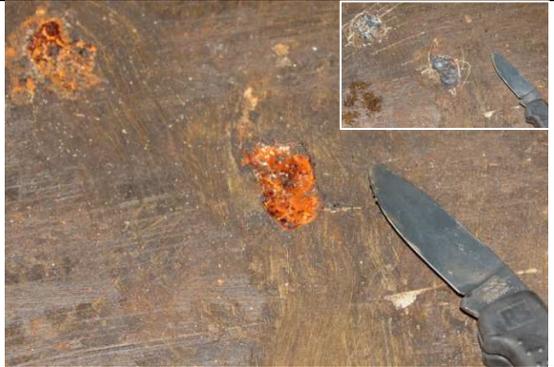
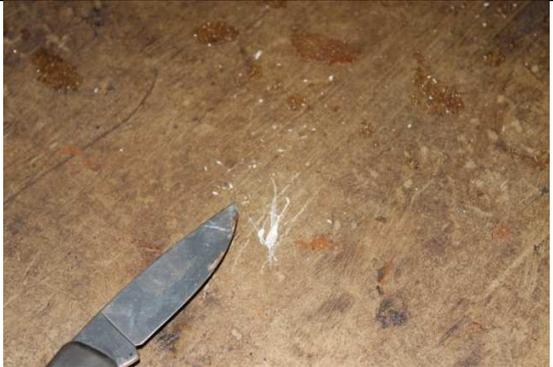
- Excellent general condition with no breakdown observed on edges or weld seams
- Corrosion pits scattered around the tanktop as a result of mechanical damage to coating. Two pits measured at approx. 15 sq.cms. Underfilm creep (measured at multiple points) recorded as zero.
- No blistering
- Adhesion to steel (Bay 7) = Excellent (rating 5/5)
- Residual layer of oil removed from the surface of one area (approx. 1 sq.m) using paint thinner
 - Coating in excellent condition
 - DFT measurements = 501-754µm
 - [See photographs #29-31 in section 6]
- Total area breakdown <0.3%

No breakdown on complex weld areas	Two corrosion pits (approx. 15 sq.cm each) caused by mechanical damages No underfilm creep of coating	Adhesion to steel check (rating = 5/5)

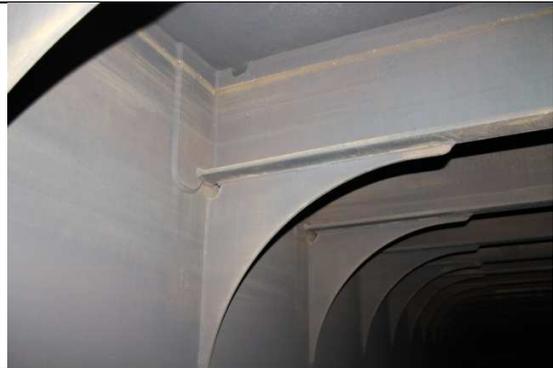
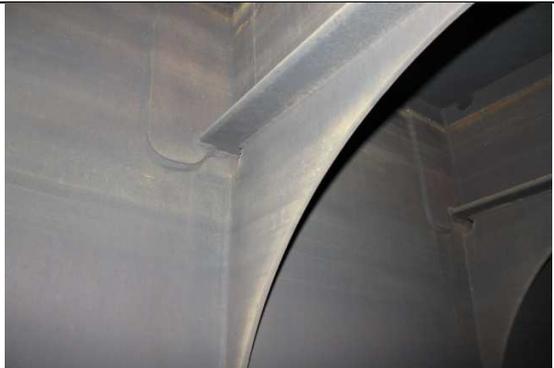
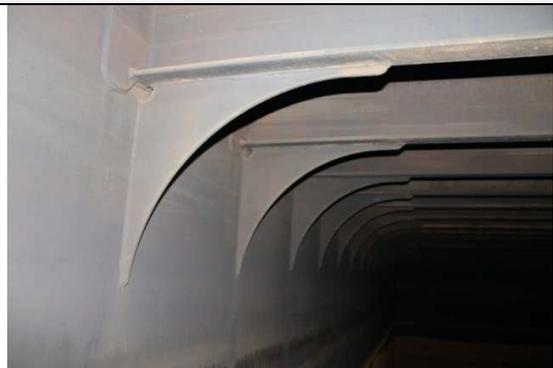
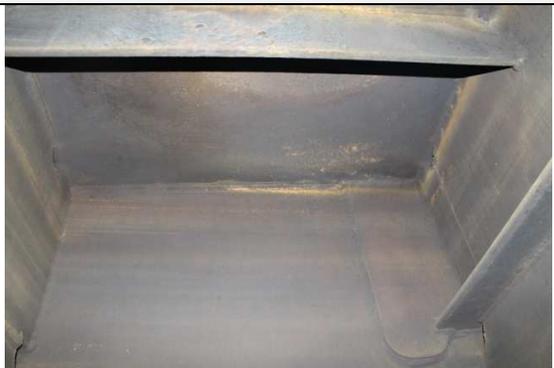
No.4 (C) - Upper	
Photo #35	Photo #36

Deckhead and connecting brackets	Excellent overall condition
Photo #37	Photo #38

Area immediately surrounding tank entrance	Minor breakdown along stiffener and one weld seam

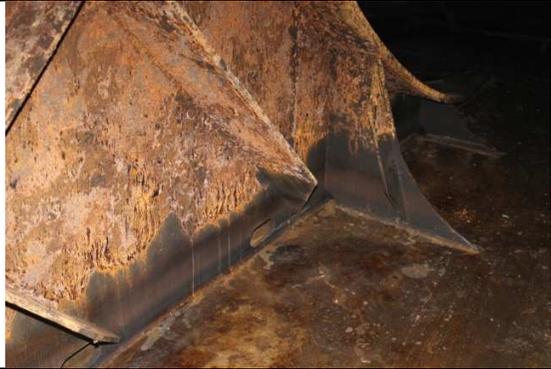
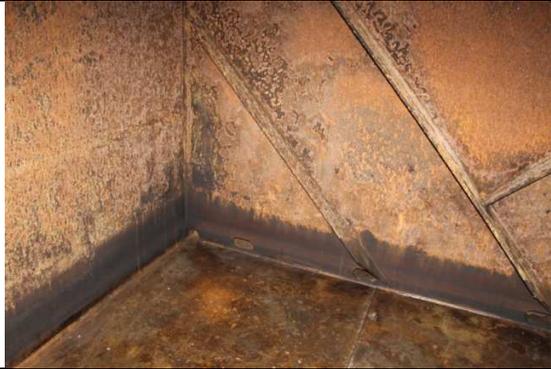
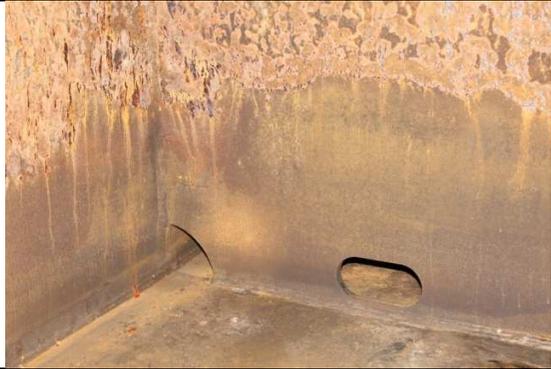
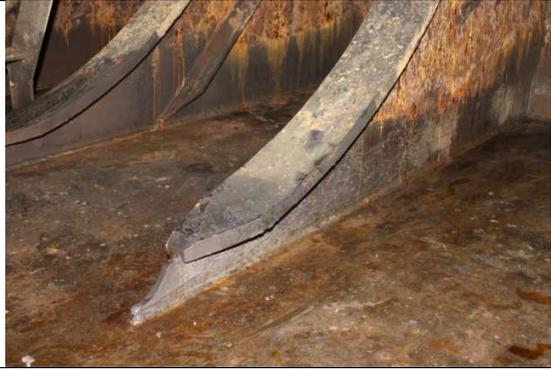
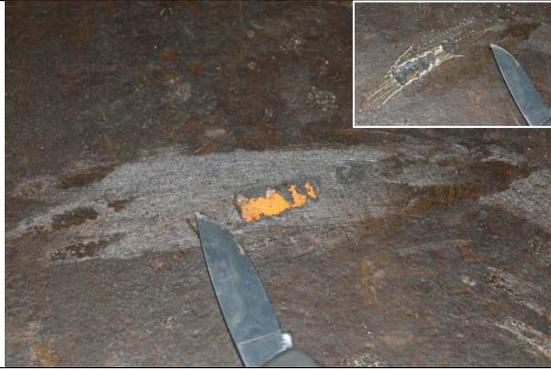
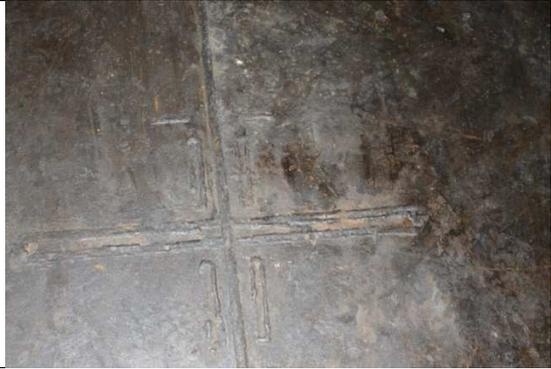
No.4 (C) - Lower		
Photo #39	Photo #40	Photo #41

Tanktop	Excellent general condition	No breakdown on scallops and edges of drainage holes
Photo #42	Photo #43	Photo #44

No breakdown on edges and weld seams	Corrosion pit caused by mechanical damage No underfilm creep	Erection joints

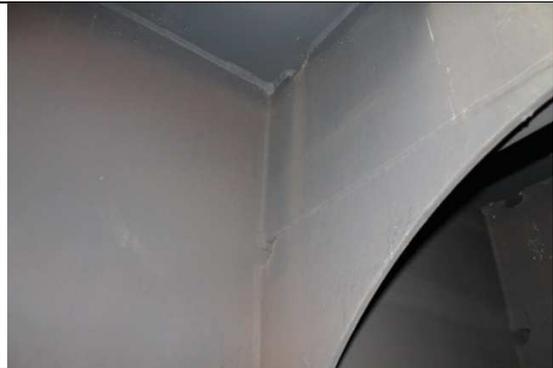
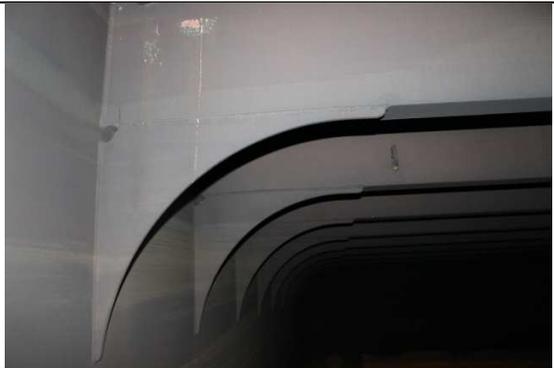
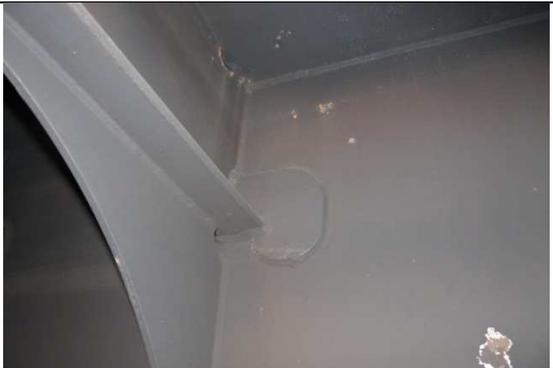
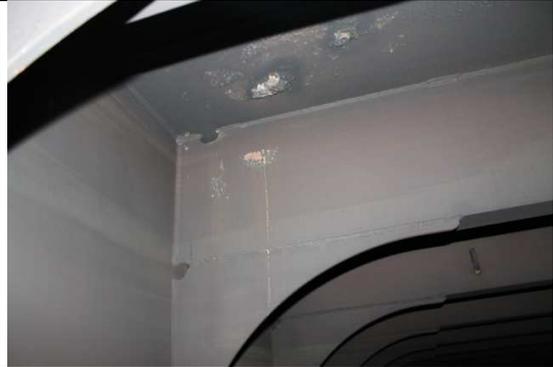
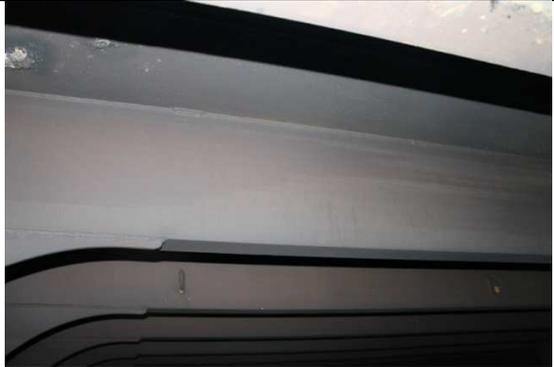
No.4 (P) - Upper		
Photo #45	Photo #46	Photo #47

- Excellent general condition in tank access areas
- Some minor breakdown in areas directly adjacent to tank entrance
 - Underside of main deck where hot work has been carried out
 - One isolated area on transverse bulkhead
 - Inside one scallop
 - One small area on deckhead support bracket
- No blistering
- Total area breakdown <0.1%

Deckhead and supporting brackets	Excellent overall condition	Minor areas of breakdown on scallop and transverse bulkhead
Photo #48	Photo #49

Reverse burn damage on underside of main deck	Small area of reverse burn damage (same area as photo #48) Excellent general condition

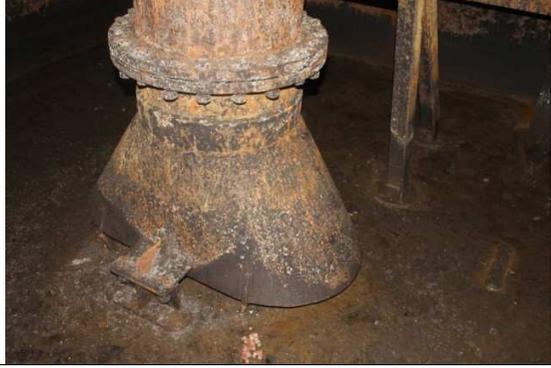
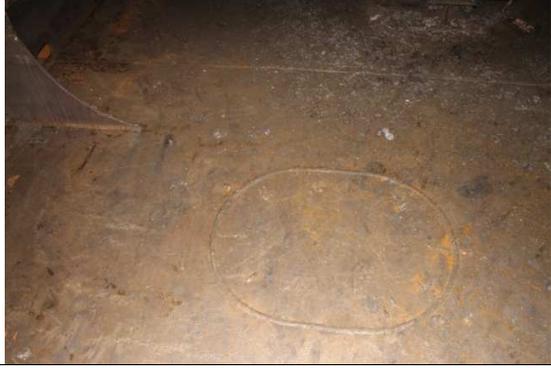
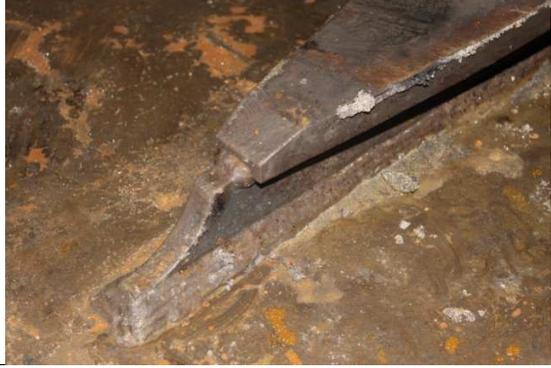
- Edges, cut-outs and scallops in excellent condition with no breakdown observed
- A few scattered corrosion pits around the tanktop at points of mechanical damage to the coating and where welds had been insufficiently ground at the new construction stage
- No blistering observed
- Fresh mechanical damage (no corrosion) around bellmouth – Intact coating in very good condition
- Total area breakdown <0.3%

Area around bellmouth in very good condition	Ground weld seams	No breakdown on sharp edges and weld seams

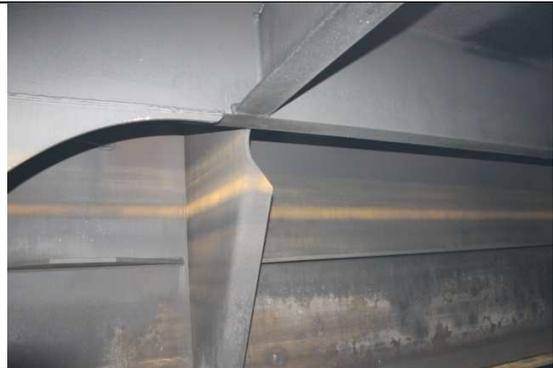
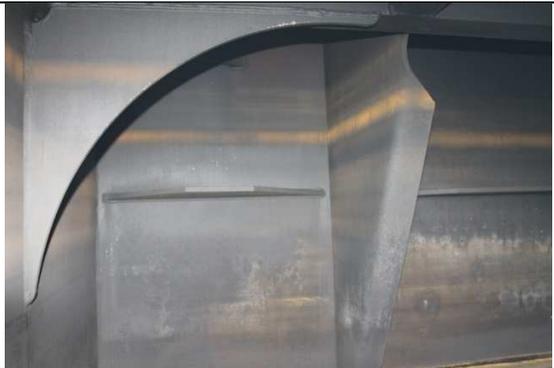
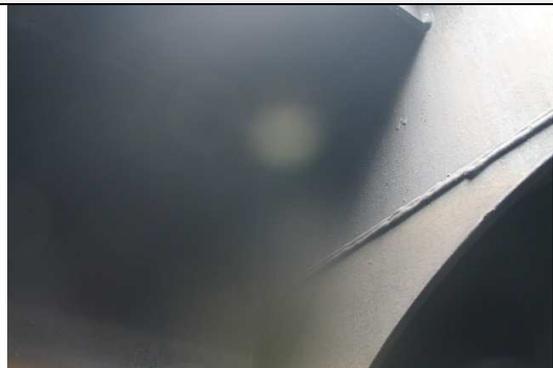
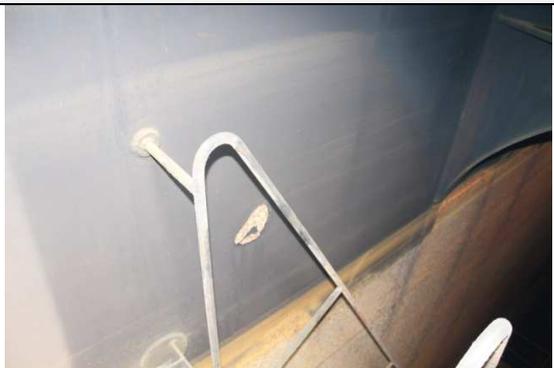
No.3 (P) - Upper	
Photo #56	Photo #57

- Excellent general condition in all areas around tank entrance
- No breakdown on edges, weld seams and cut-outs
- One isolated area (approx. 50 sq.cm) of coating breakdown on transverse bulkhead directly adjacent to top of access ladder
- No blistering
- No coating breakdown observed above, at or below the (clearly visible) cargo load line
- Total area breakdown <0.1%

Excellent general condition	No breakdown above, at or below the cargo load line
Photo #58	Photo #59

Deckhead adjacent to tank access	One isolated area of breakdown adjacent to access ladder

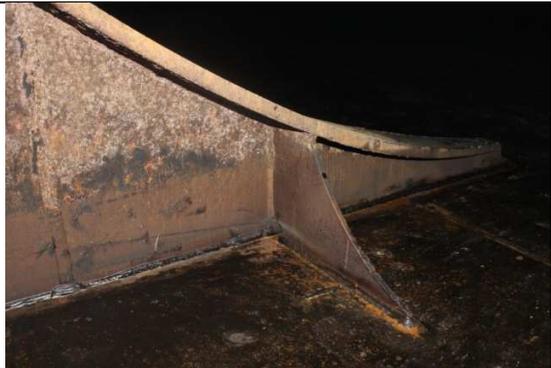
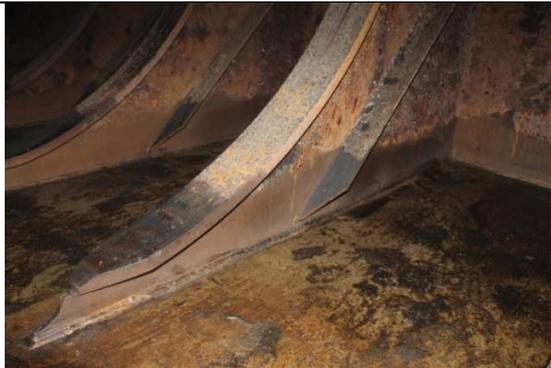
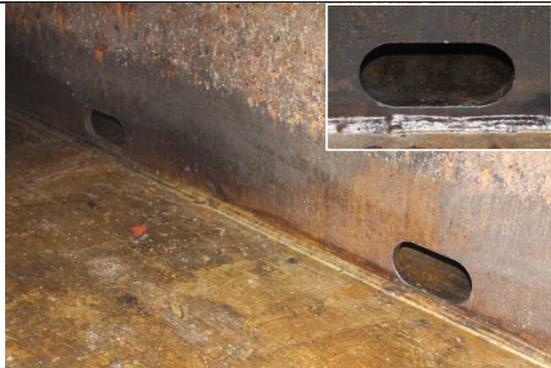
No.3 (P) - Lower		
Photo #60	Photo #61	Photo #62

- Excellent general condition with no breakdown observed on sharp edges or weld seams
- Only a few scattered corrosion pits on the tanktop resulting from mechanical damage to coating. Underfilm creep (measured at multiple points) recorded as zero.
- No blistering
- Residual layer of oil removed from the surface of one area (approx. 1 sq.m) using paint thinner
 - Coating in excellent condition
 - DFT measurements = 353-583µm
 - Two areas (<1 sq.cm) of mechanically-damaged coating. Underfilm creep measured as zero.

Tanktop	Edges and weld seams in excellent condition	No breakdown on edges of drainage holes
Photo #63	Photo #64	Photo #65

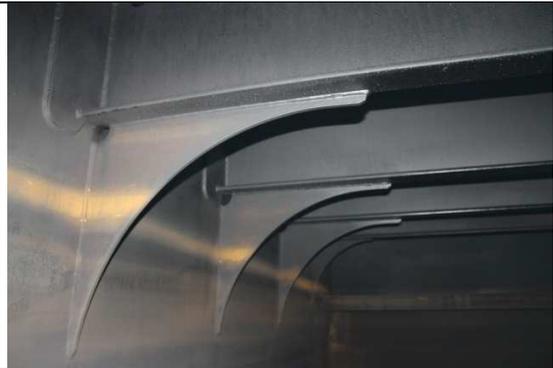
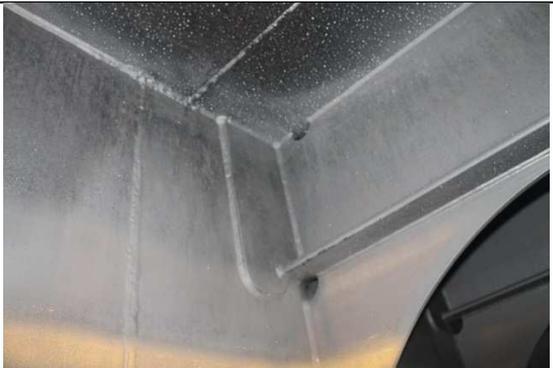
No.3 (S) - Upper		
Photo #66	Photo #67	Photo #68

- Excellent general condition in all areas around tank entrance
- No breakdown observed on edges, weld seams and cut-outs
- No blistering
- Total area breakdown <0.1%

No breakdown above, at or below cargo load line	Deckhead area adjacent to tank access	Excellent general condition

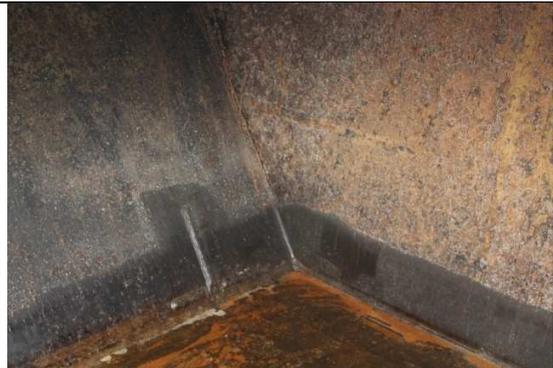
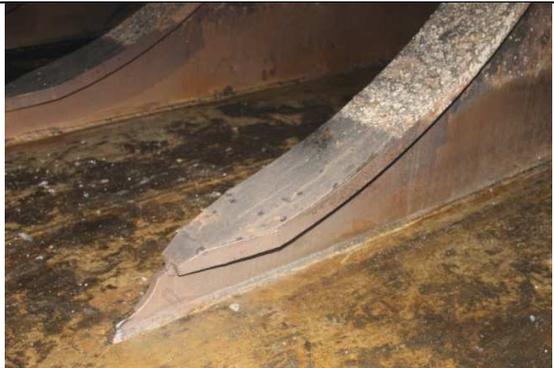
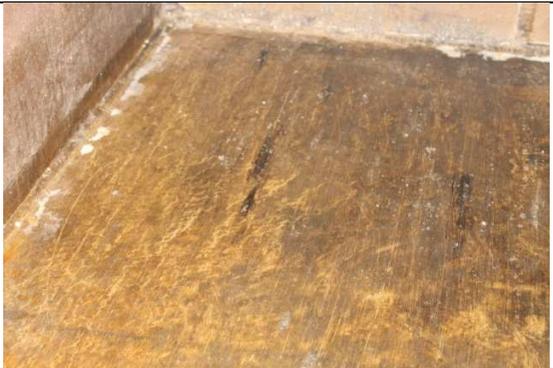
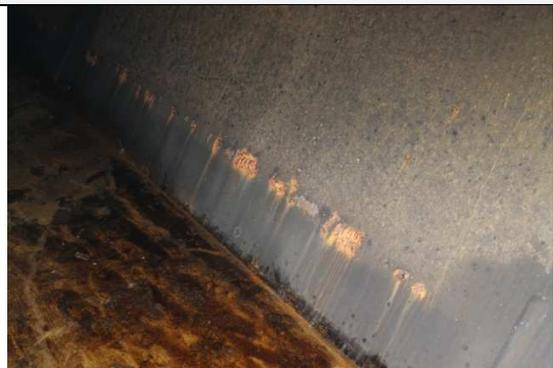
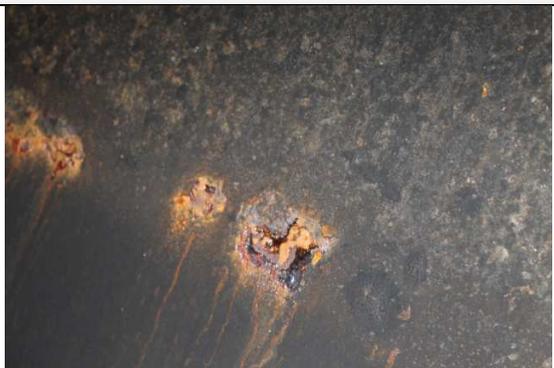
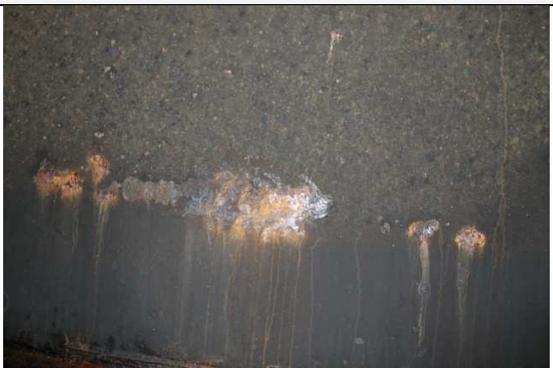
No.3 (S) - Lower		
Photo #69	Photo #70	Photo #71

- Edges and weld seams on lower bulkhead areas and support brackets in excellent general condition with no breakdown observed
- A few scattered corrosion pits on the tanktop resulting from mechanical damage to coating and ground welds. Underfilm creep measured as zero.
- No blistering
- Coating still fully intact where scratch marks visible from removal of crude oil using shovels
- Corrosion (heavy in some areas) visible on the outer bulkhead above the area coated with Intershield[®]300. The coated area extended approx. 0.2m up the bulkhead, where cargoes containing high water content can exceed this level.
 - Rust scale could easily be removed using a penknife above the coated area
 - No underfilm creep was observed below the coated area (i.e. the coating was still fully adherent and protecting the substrate)
- Total area breakdown <0.3%

Tanktop	No breakdown on sharp edges and weld seams	Surface scratches from shovels used to remove crude oil – coating still intact
Photo #72	Photo #73	Photo #74

Coating scheme applied to approx. 0.2m up the bulkhead	Corrosion above the coated area	No underfilm creep below coated area

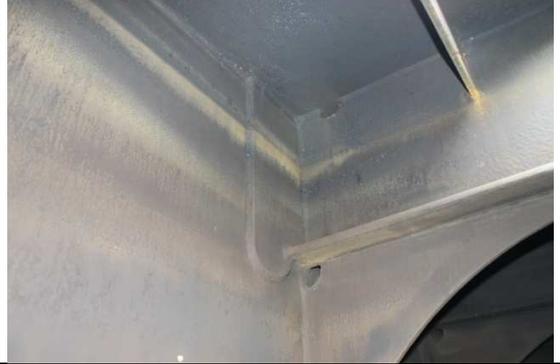
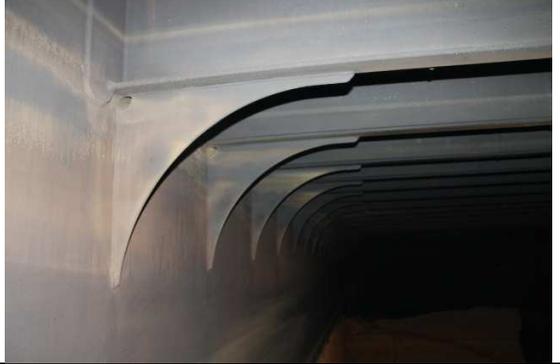
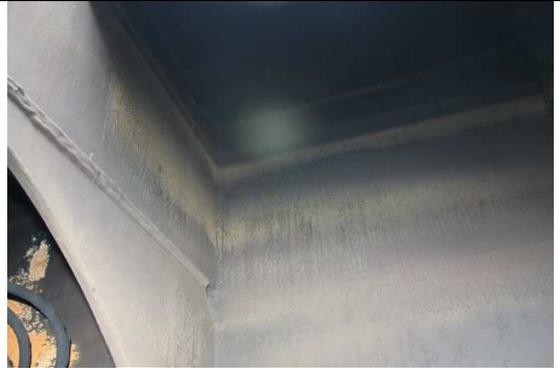
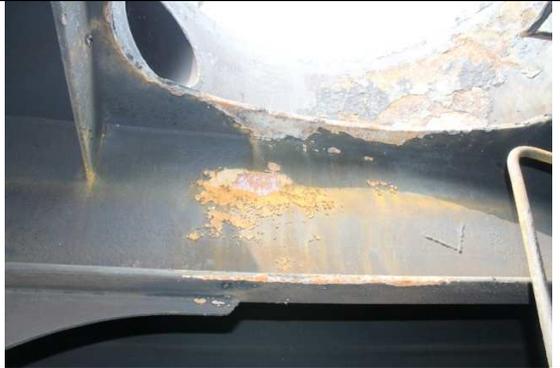
No.2 (C) - Upper	
Photo #75	Photo #76

- Excellent general condition on deckhead, supporting brackets and upper bulkhead areas
- Some corrosion caused by mechanical damages in tank access areas (immediate vicinity of manhole) and behind coils in adjacent bay
- No blistering
- Total area breakdown <0.1%

Deckhead and supporting brackets	No breakdown above, at or below cargo load line
Photo #77	Photo #78

Excellent general condition Some corrosion behind coils visible in adjacent bay	Corrosion caused by mechanical damage immediately adjacent to tank entrance

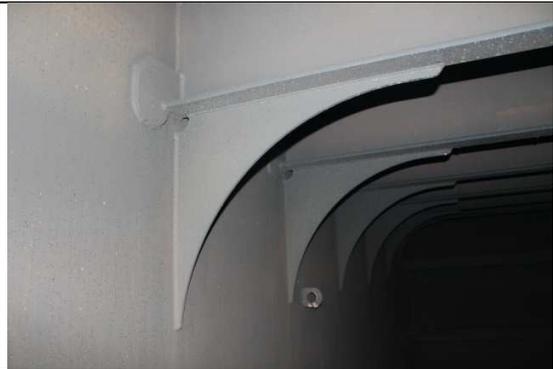
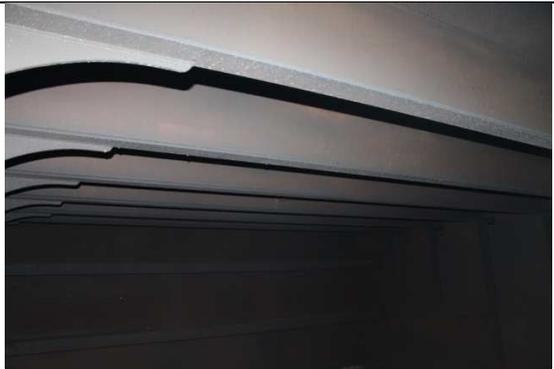
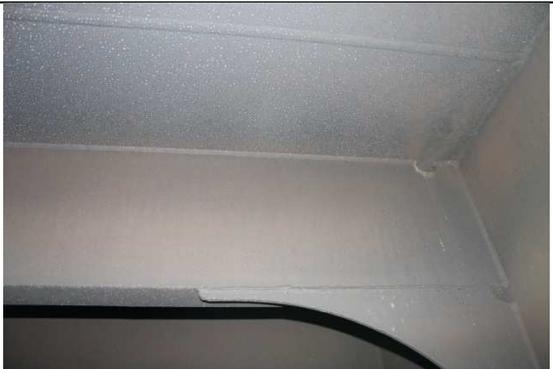
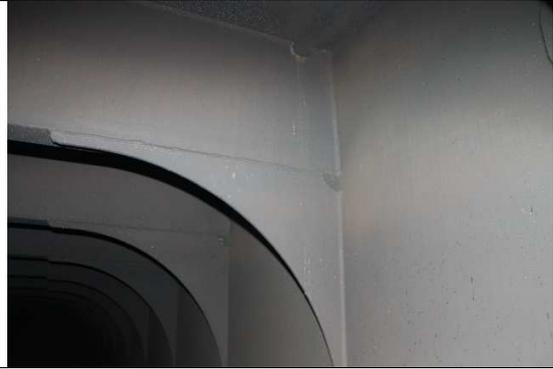
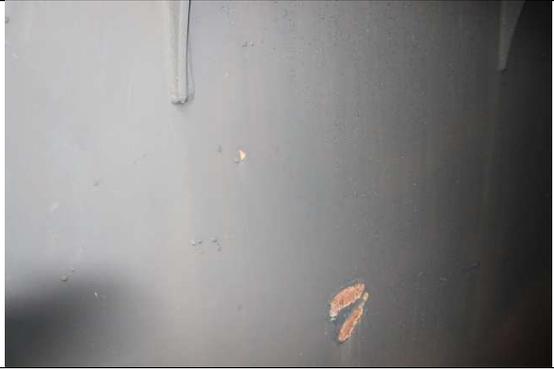
No.1 (S) - Upper		
Photo #85	Photo #86	Photo #87

- Very good overall condition on deckhead, supporting brackets and upper bulkheads
- Some minor areas of breakdown observed inside one scallop and on one edge
- Transverse bulkhead directly adjacent to top of access ladder
 - Two contiguous areas of coating breakdown (approx. 130 sq.cm in total)
 - One area of scattered blisters
- Total area breakdown <0.1%

Deckhead areas in excellent general condition	Underside of main deck	Minor breakdown inside rathole
Photo #88	Photo #89

Deckhead and connecting brackets	Scattered blisters and minor breakdown adjacent to top of access ladder
