“Samco Raven”

IMO 9107655

Crude Oil Tank Inspection Report

25-26 August 2011

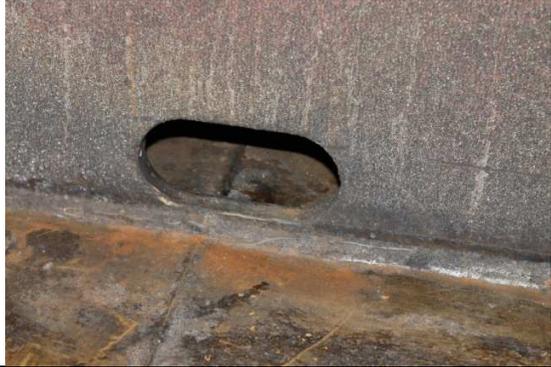
Tanktop	Excellent general condition	No breakdown on edges of drainage holes
Photo #22	Photo #23	Photo #24

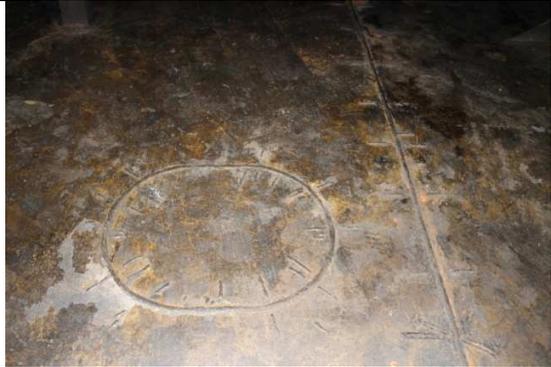
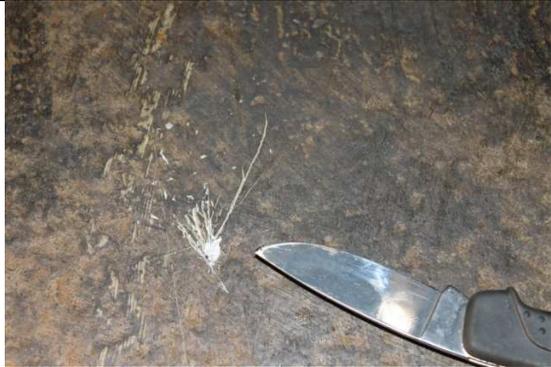
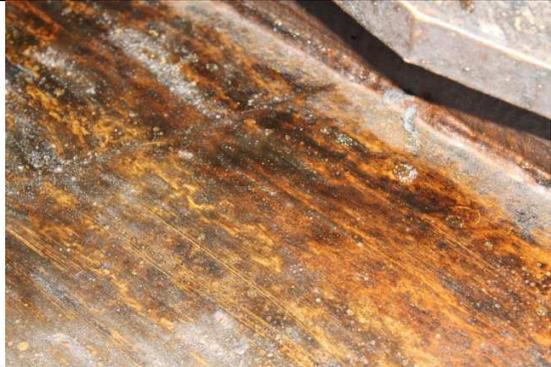
Erection joint (one corrosion pit) and weld seams	Adhesion to steel check (rating = 5/5)	Surface scratches from shovels

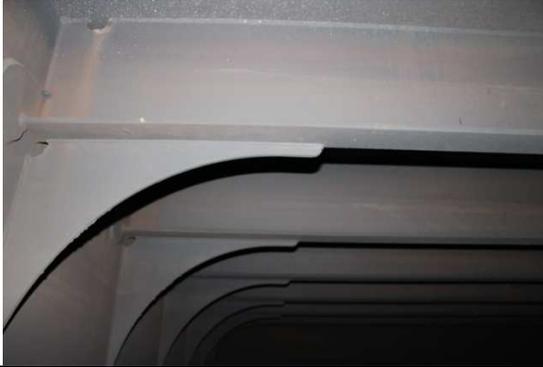
Excellent general condition	Deckhead and connecting brackets
Photo #27	Photo #28

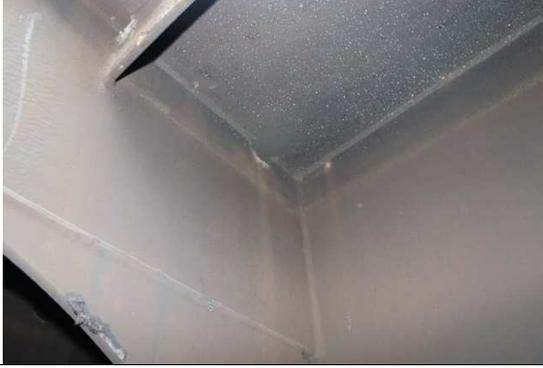
One small area of breakdown on edge of bracket	Minor breakdown on inside of scallop and edge

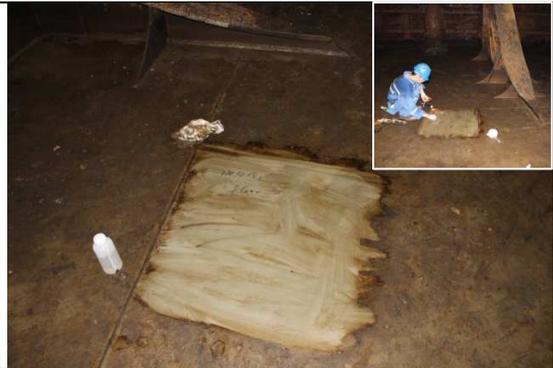
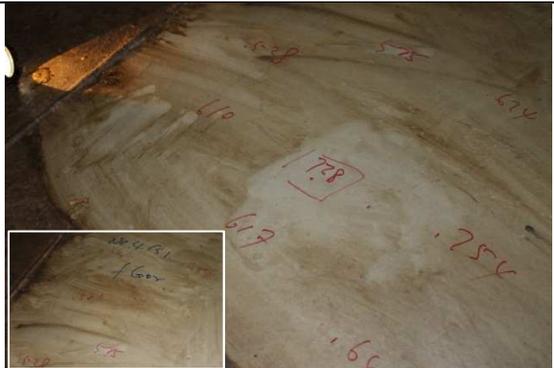
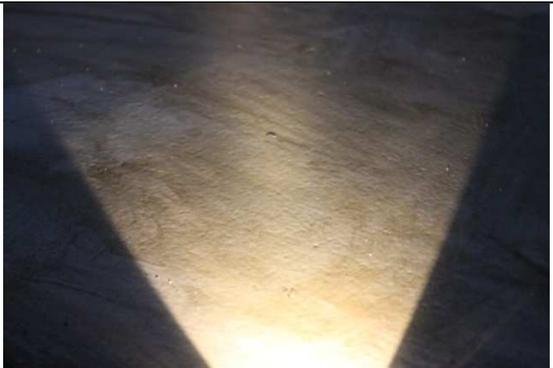
No.4 (S) - Lower		
Photo #29	Photo #30	Photo #31

- Excellent general condition with no breakdown observed on edges or weld seams
- Corrosion pits scattered around the tanktop as a result of mechanical damage to coating. Two pits measured at approx. 15 sq.cms. Underfilm creep (measured at multiple points) recorded as zero.
- No blistering
- Adhesion to steel (Bay 7) = Excellent (rating 5/5)
- Residual layer of oil removed from the surface of one area (approx. 1 sq.m) using paint thinner
 - Coating in excellent condition
 - DFT measurements = 501-754µm
 - [See photographs #29-31 in section 6]
- Total area breakdown <0.3%

Removal of residual oil layer from surface of coating using paint thinners	DFT checks (501-754µm)	Appearance of coating after cleaning
Photo #32	Photo #33	Photo #34

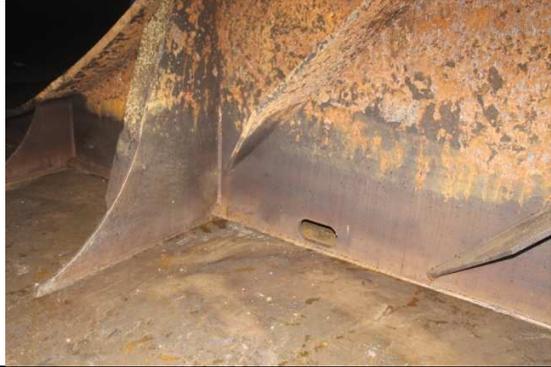
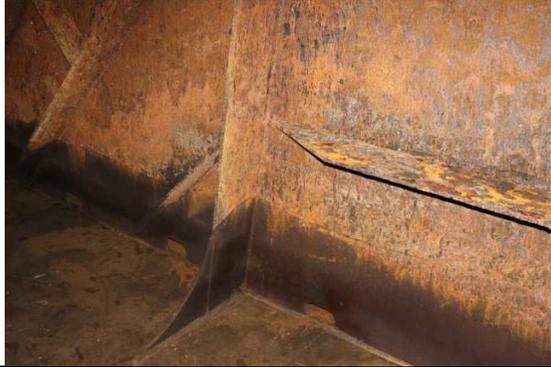
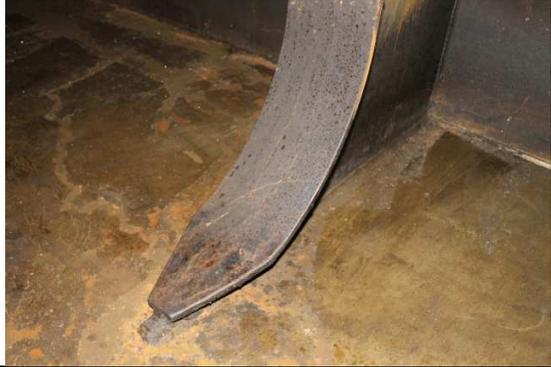
No.4 (P) - Lower		
Photo #50	Photo #51	Photo #52

Tanktop	Excellent general condition	Supporting brackets
Photo #53	Photo #54	Photo #55

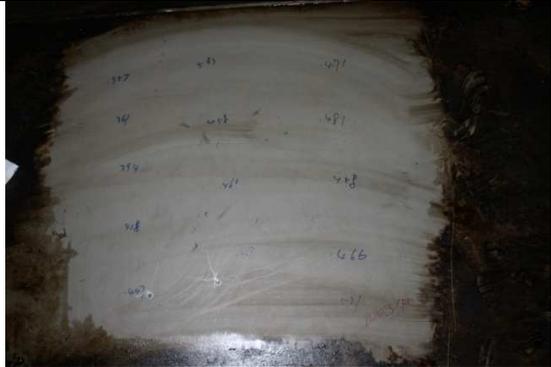
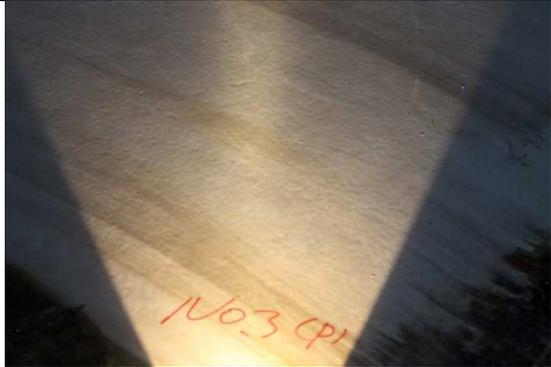
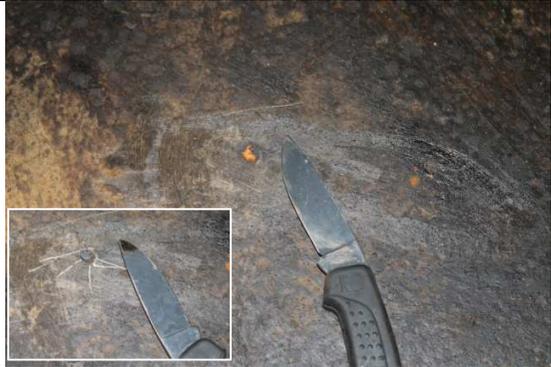
Tanktop	Edges and weld seams in excellent condition	No breakdown on edges of drainage holes
Photo #63	Photo #64	Photo #65

- [See photographs #63-64 in section 6]
- One crack at the foot of the access ladder
- Total area breakdown <0.3%

Oil layer removed from surface DFT checks (353-583µm) Two areas (<1 sq.cm) of mechanical damage - no underfilm creep	Appearance of coating after cleaning	Corrosion pit caused by mechanical damage No underfilm creep

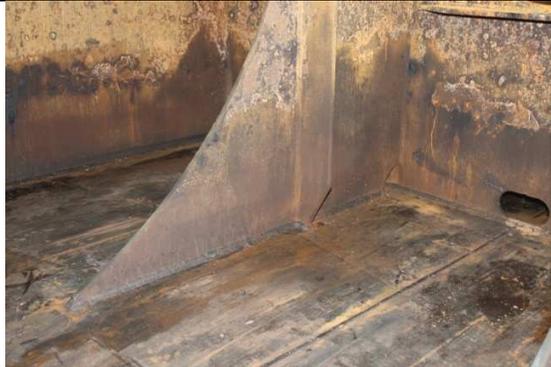
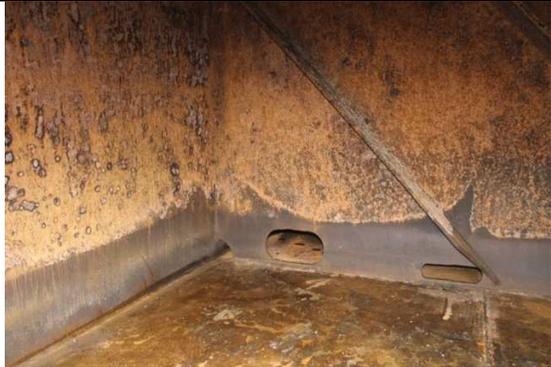
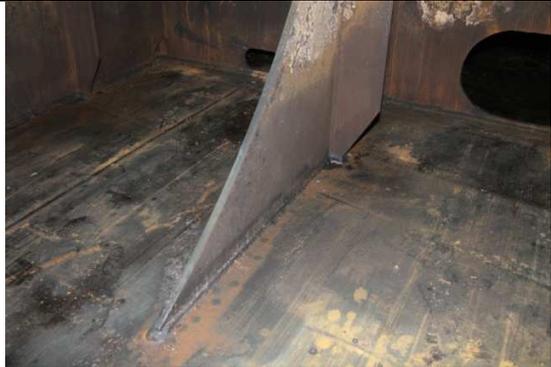
No.2 (C) - Lower		
Photo #79	Photo #80	Photo #81

Tanktop in excellent general condition	No breakdown on scallops and edges of rat holes	Surface scratches from shovels
Photo #82	Photo #83	Photo #84

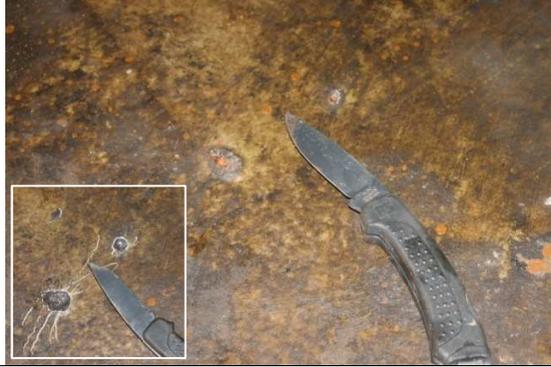
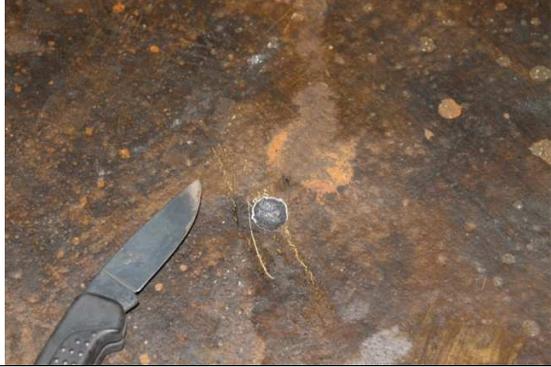
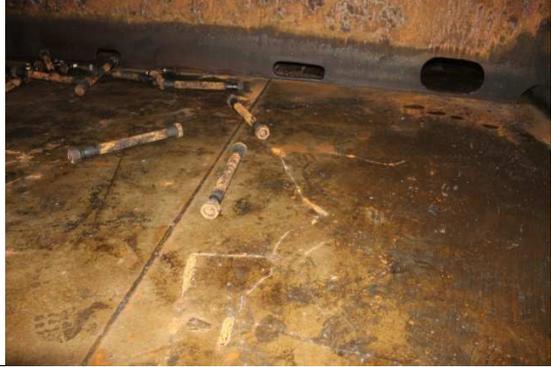
Corrosion pits caused by mechanical damage Small amount of underfilm creep (5mm)	Corrosion pit caused by mechanical damage No underfilm creep	Distinctly shaped corroded areas on tanktop caused by heavy mechanical damage

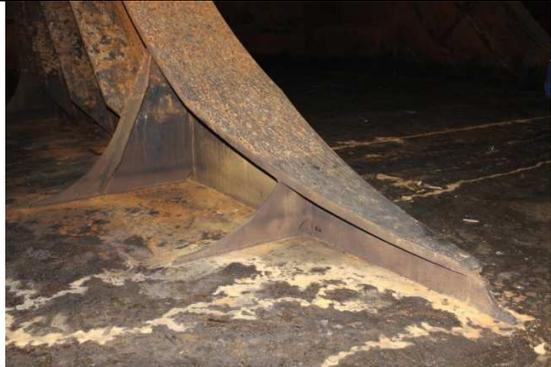
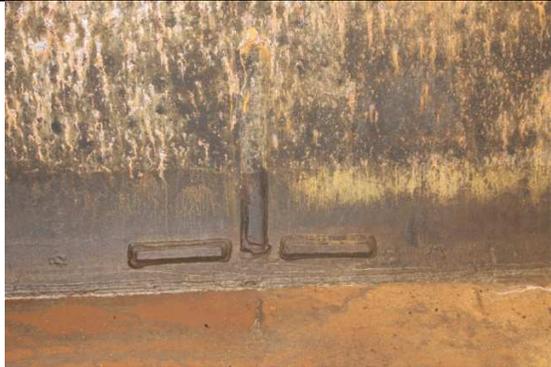
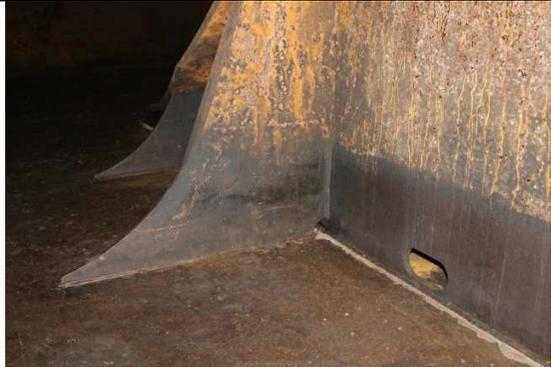
No.1 (S) - Lower		
Photo #90	Photo #91	Photo #92

No breakdown on sharp edges, weld seams and inside scallops	Ground welds defect-free	Tanktop in excellent general condition
Photo #93	Photo #94	Photo #95

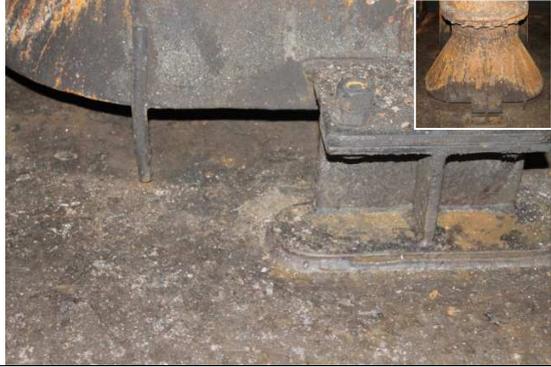
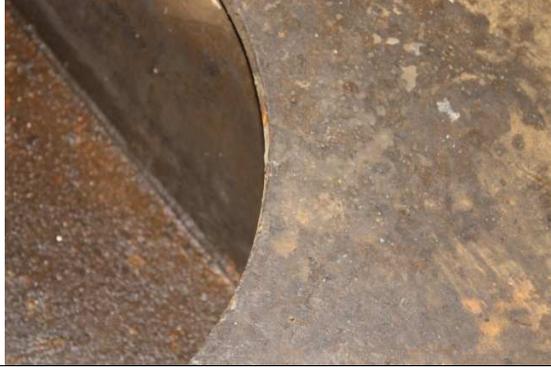
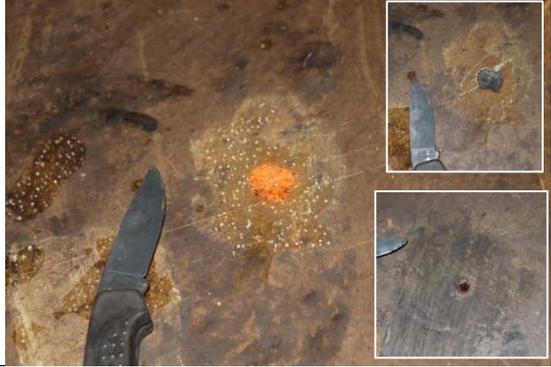
Area around bellmouth in excellent condition	No breakdown on edges around cargo well	Corrosion pit caused by mechanical damage No underfilm creep Coating repairs to damaged areas by brush application visible from new construction stage
